June 28, 2019
File No. 262018.063

Subject: Department of Natural Resources Washington Geological Survey,
School Seismic Safety Assessment Project, Contract No. AE 410 -
Seismic Evaluation for **Puyallup School District**

School Buildings Evaluated in the Puyallup School District

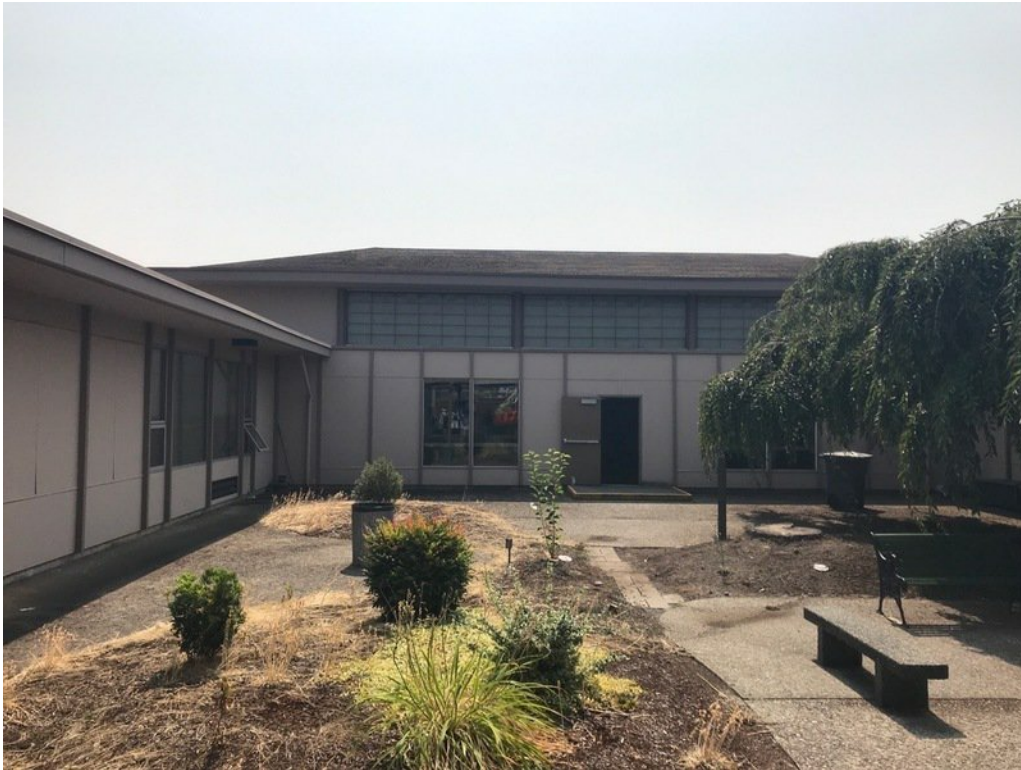
Figure 1-1. Courtyard

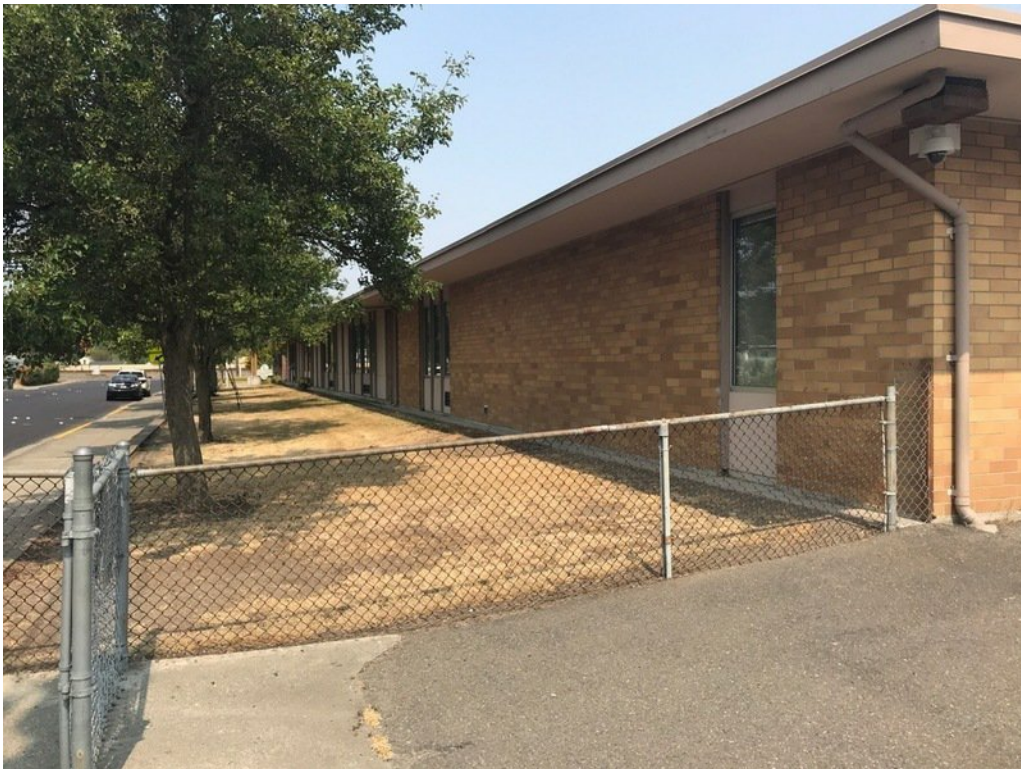
Figure 1-2. West façade

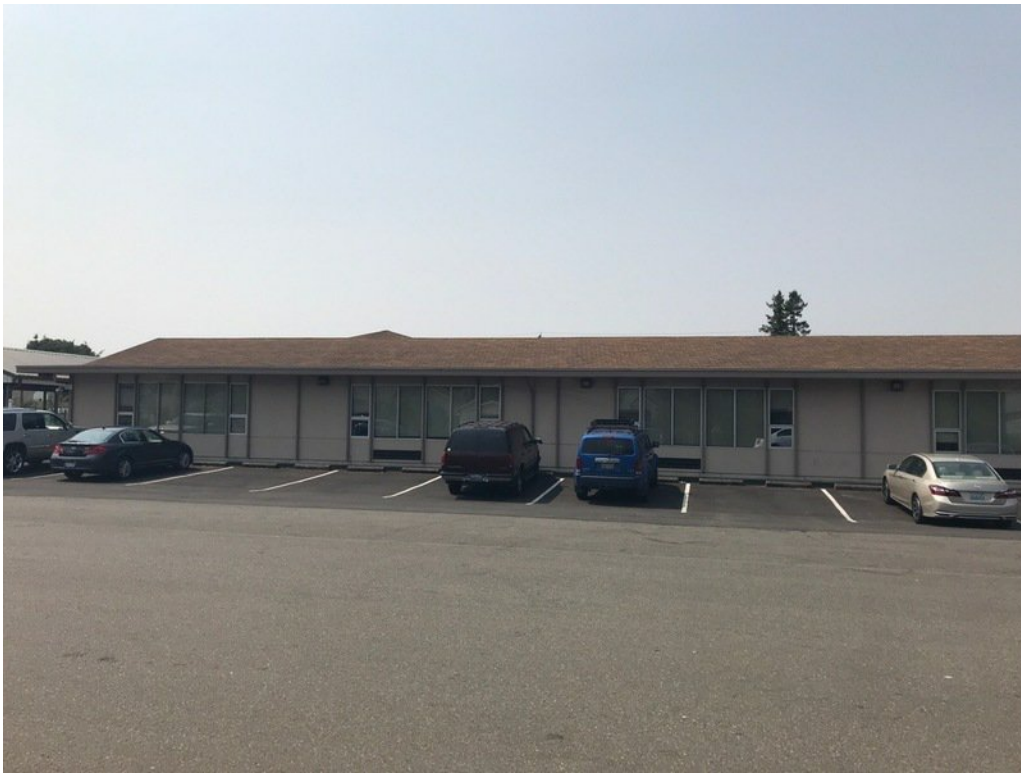
Figure 1-3. East façade

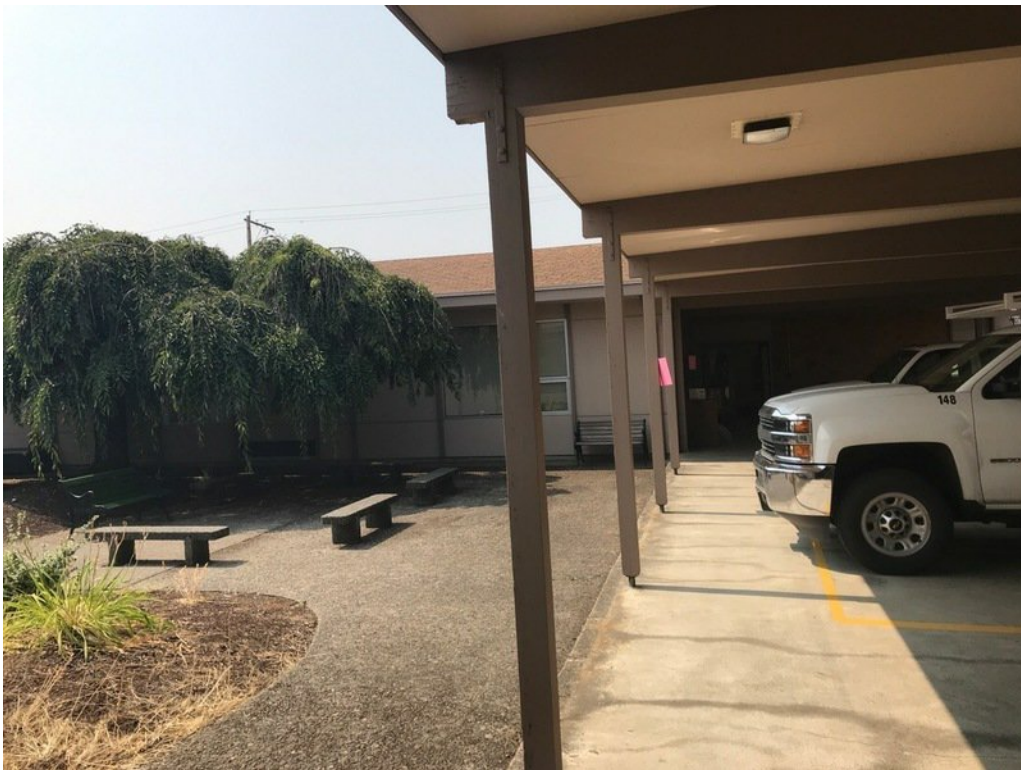
Figure 1-4. Courtyard and covered play area

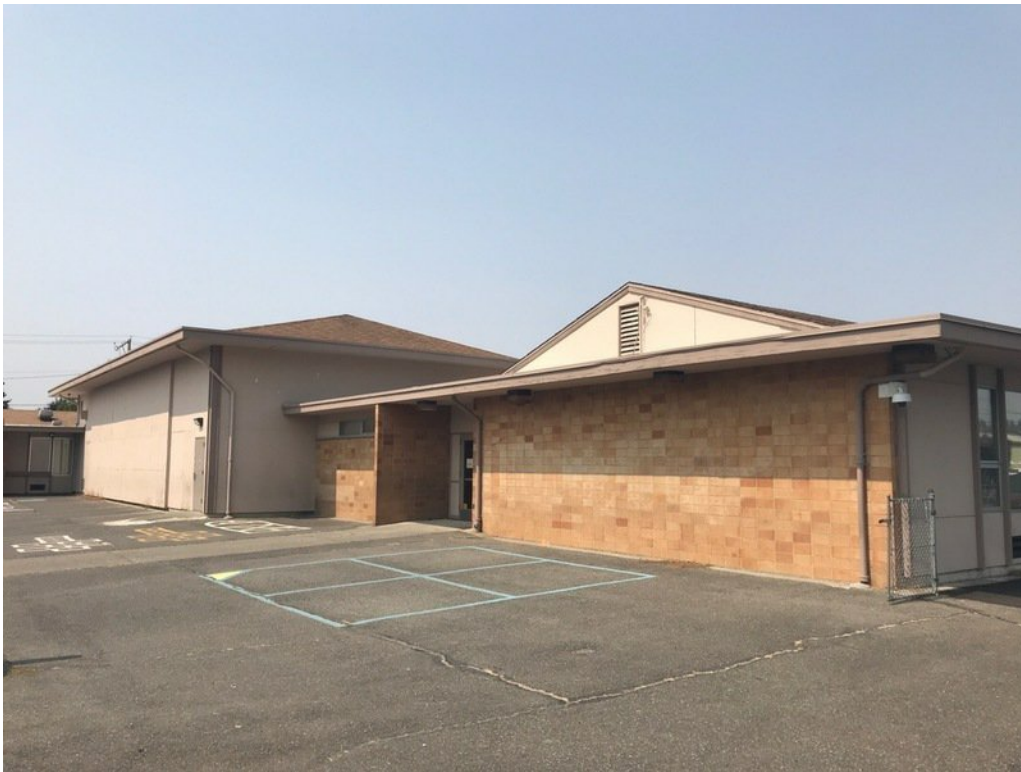
Figure 1-5. South façade

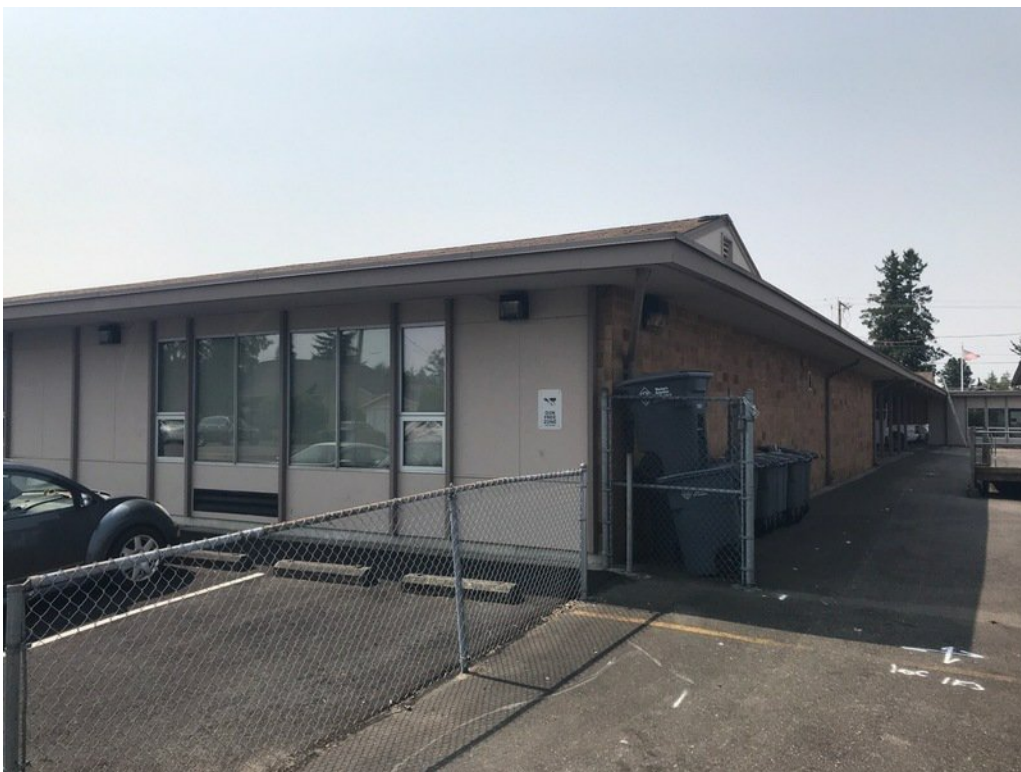
Figure 1-6. North-east corner

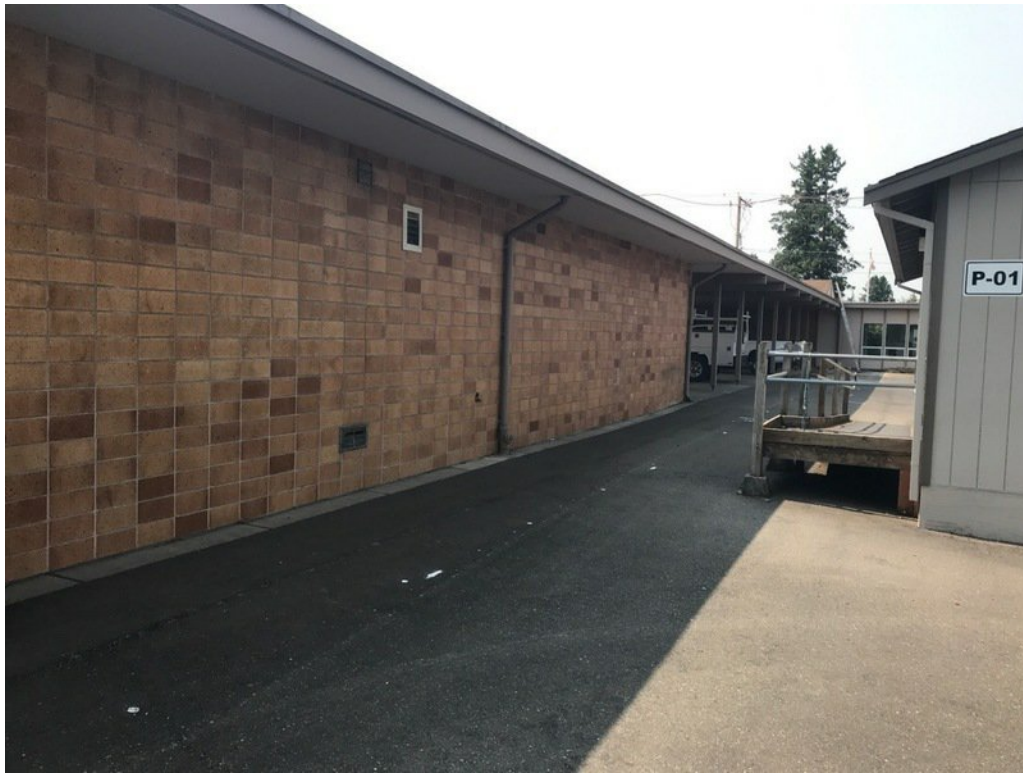
Figure 1-7. North façade of

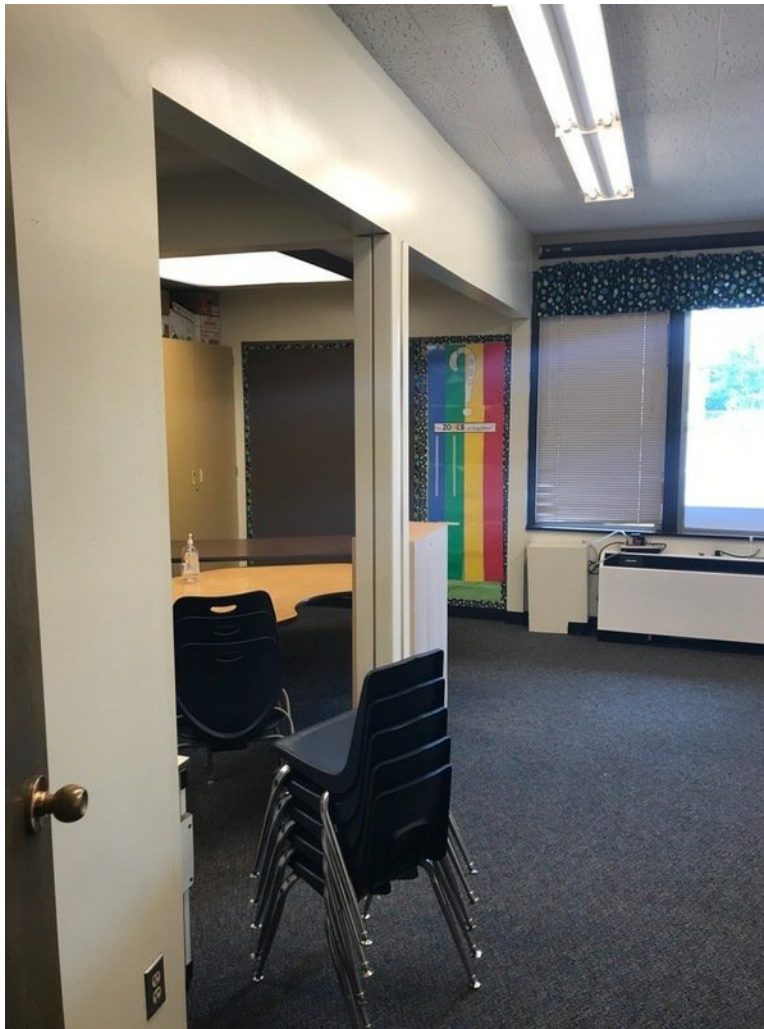
Figure 1-8. Classroom

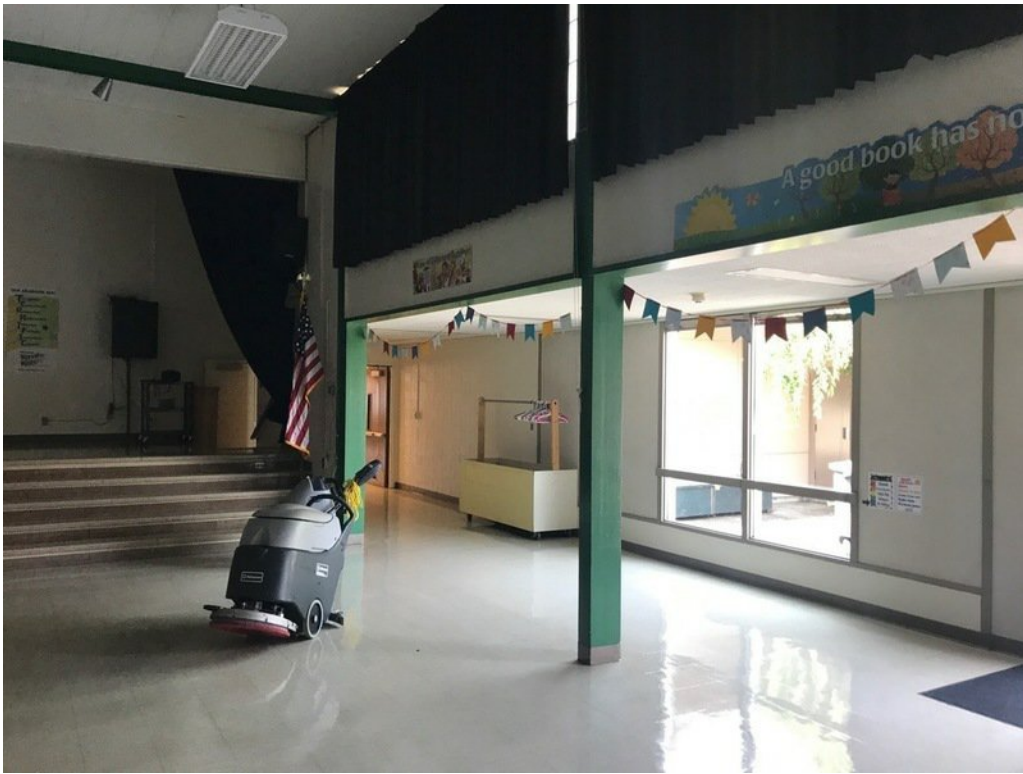
Figure 1-9. Multi-purpose room

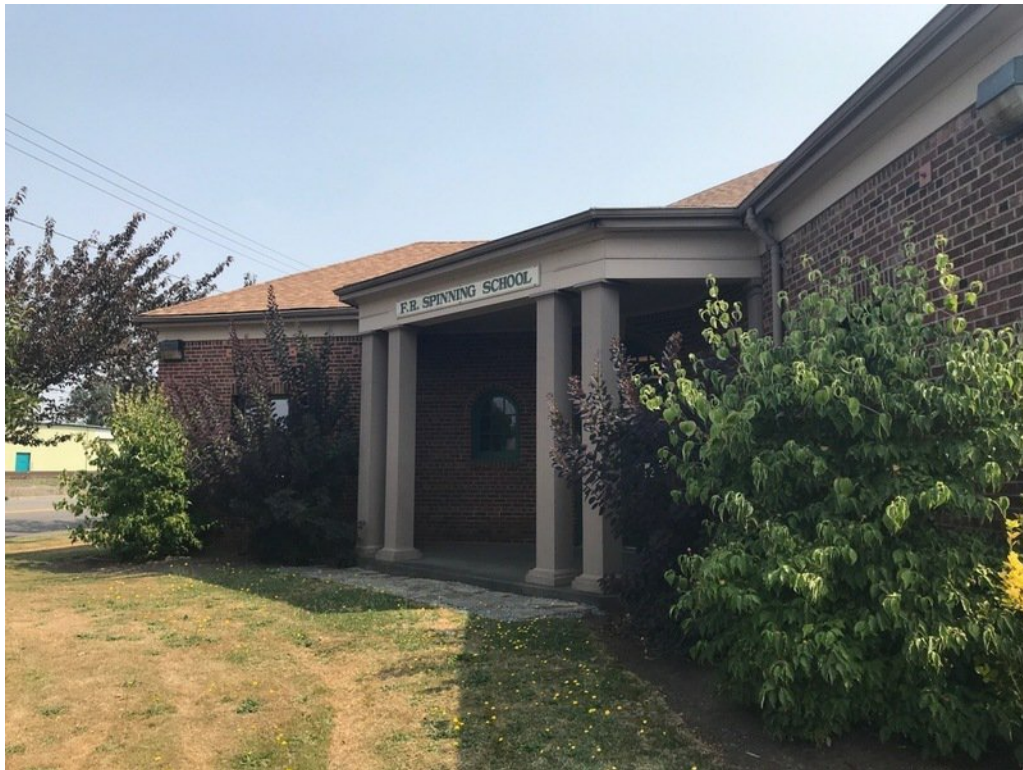
Figure 1-1. Former main entry

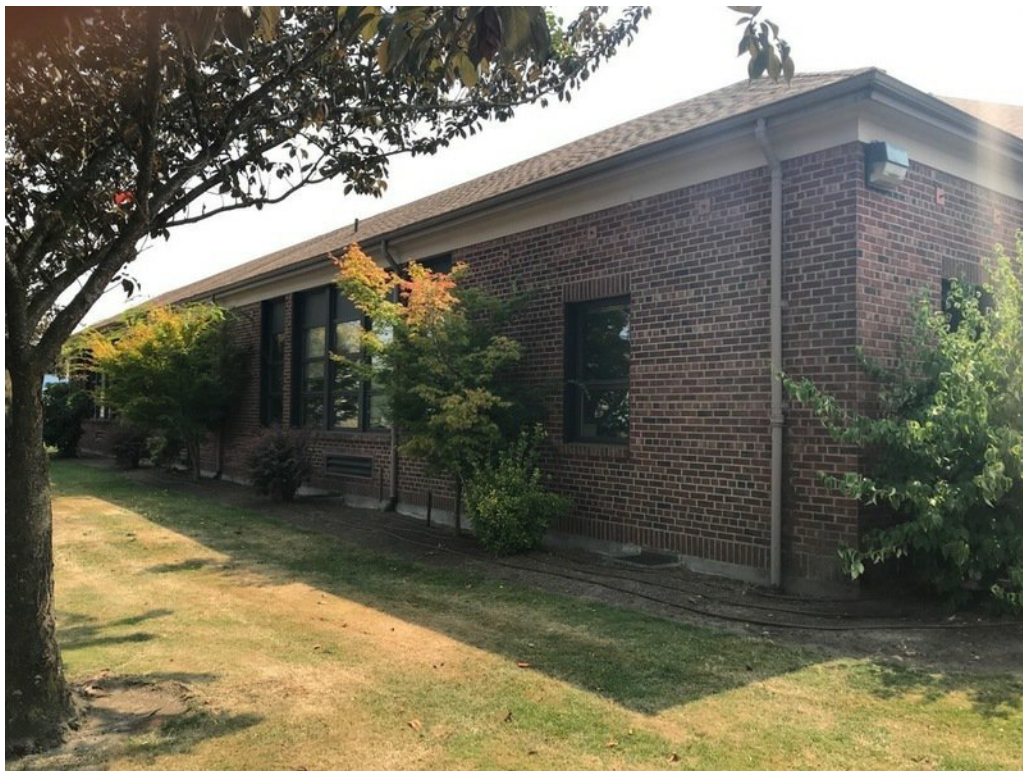
Figure 1-2. North-west corner

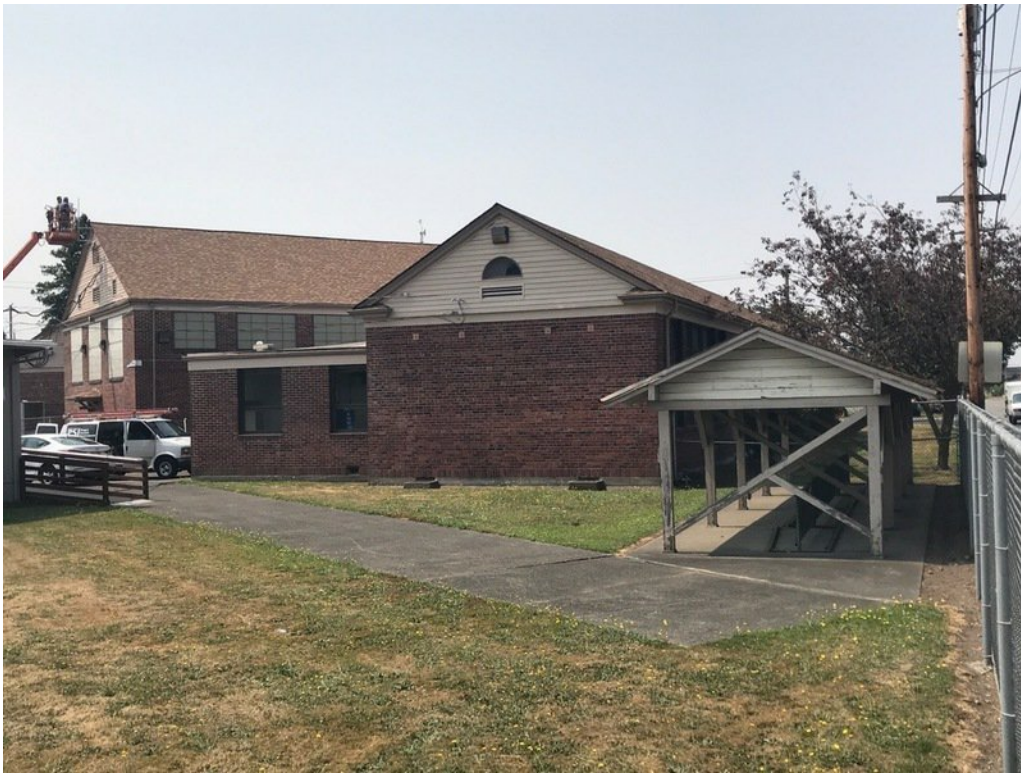
Figure 1-3. East façade, multi-purpose portion of building in the back ground.

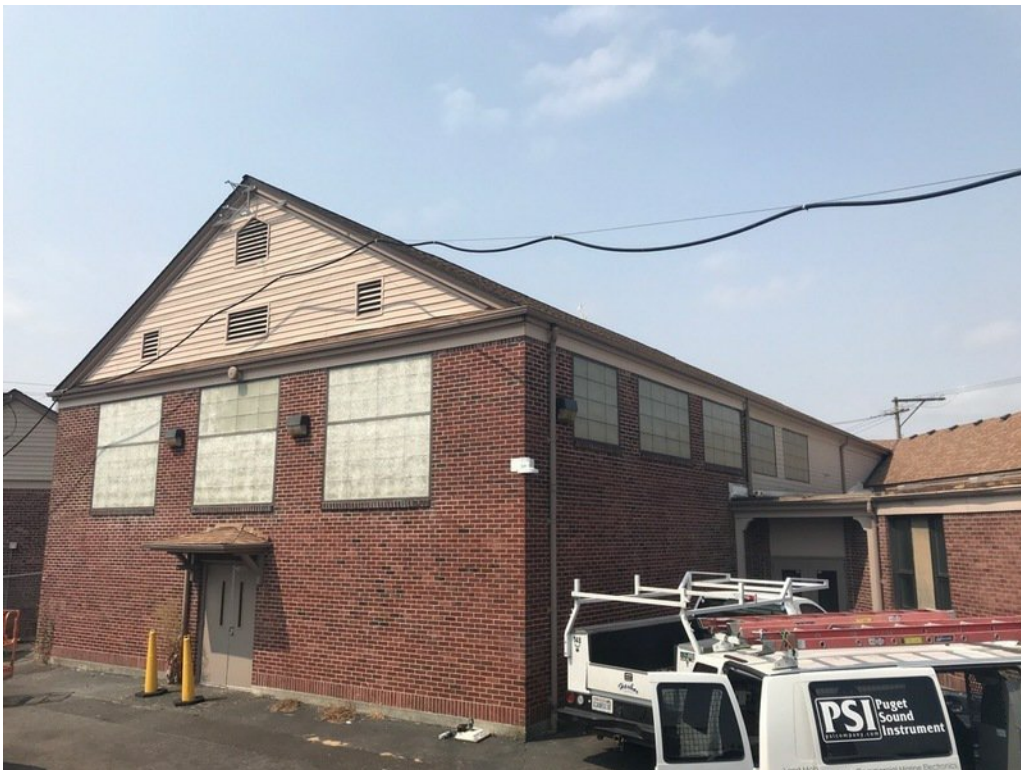
Figure 1-4. South façade multi-purpose area

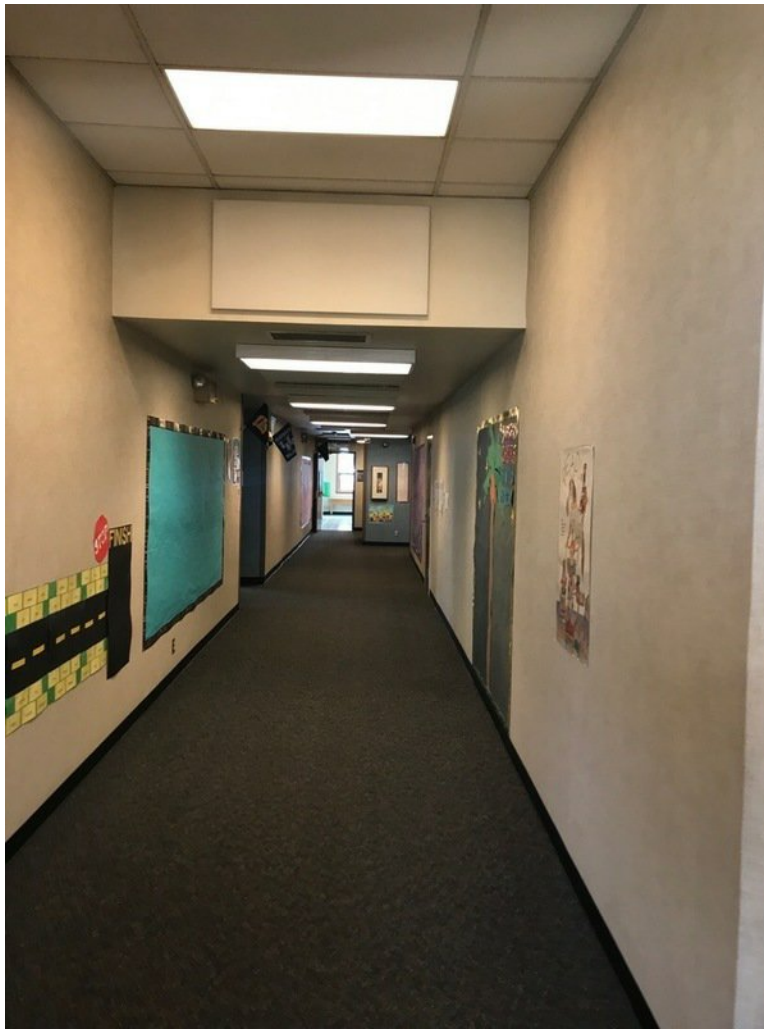
Figure 1-5. Corridor

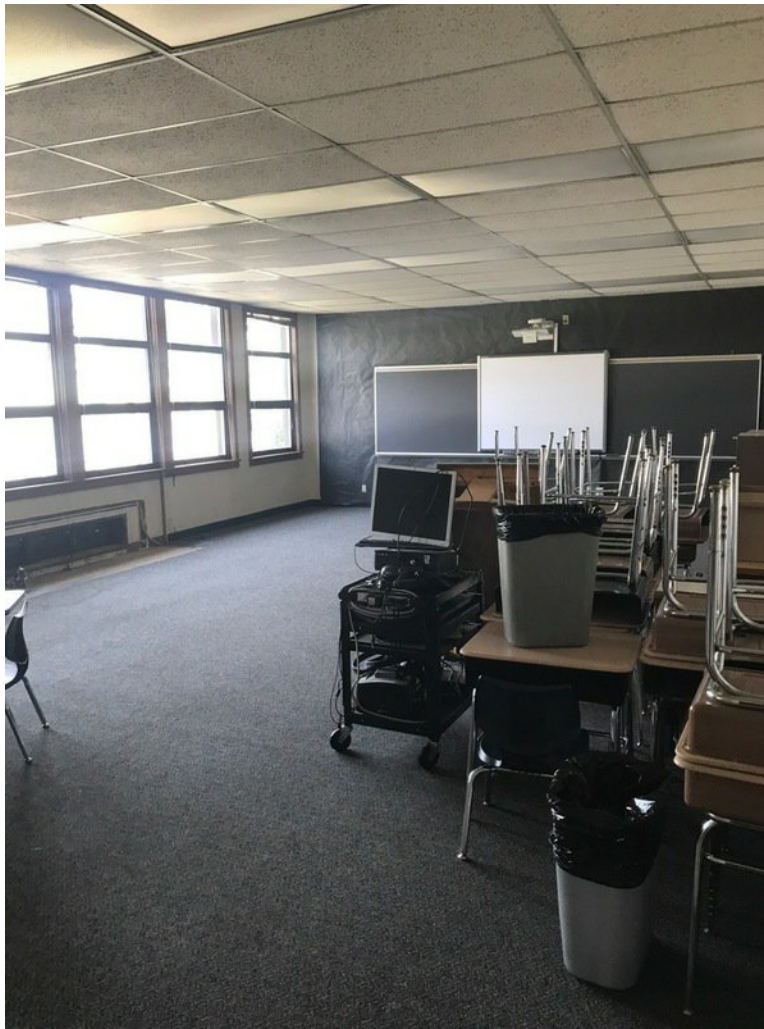
Figure 1-6. Classroom

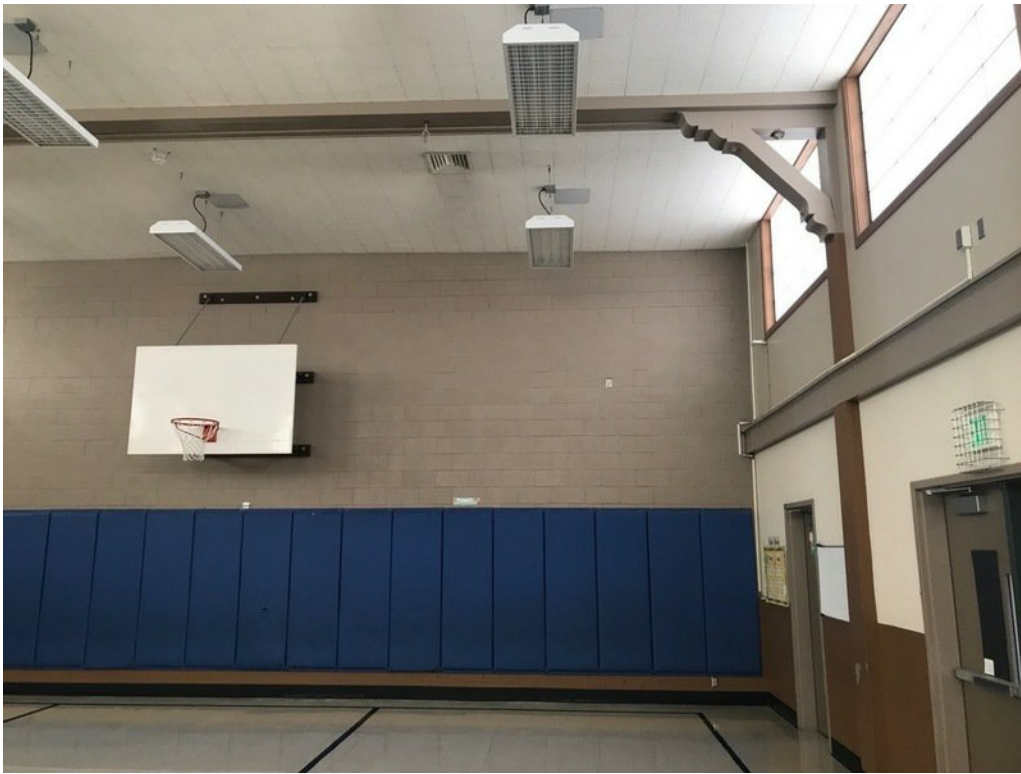
Figure 1-7. Multipurpose room

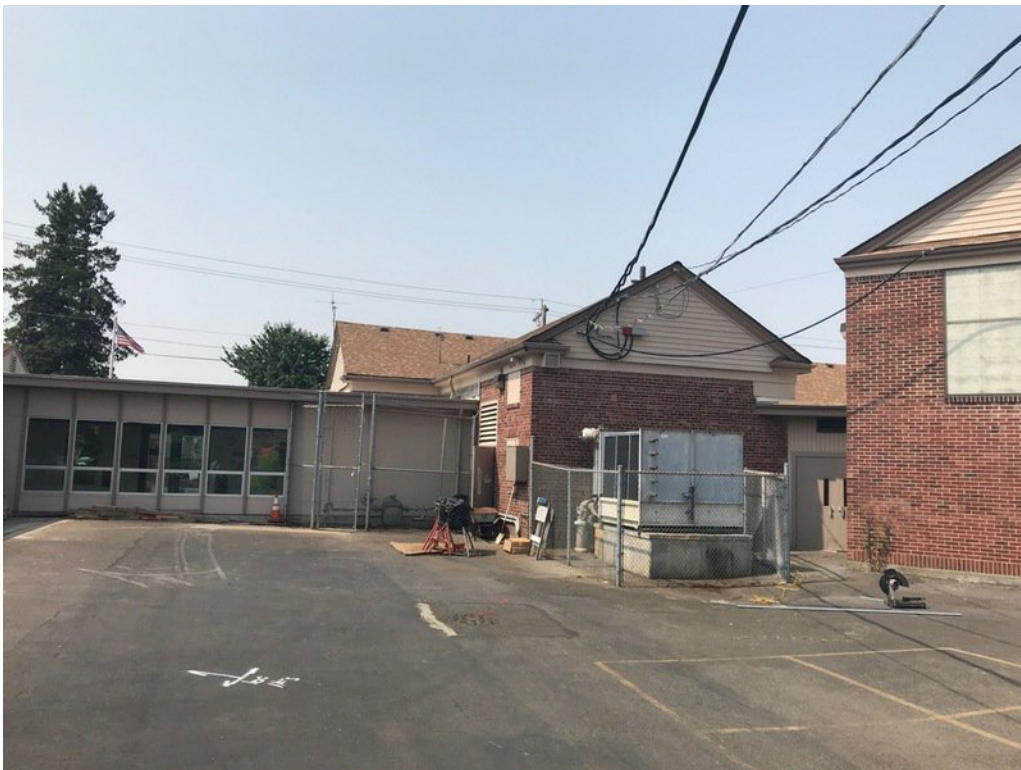
Figure 1-8. Exterior of mechanical room and connection to 1971 structure

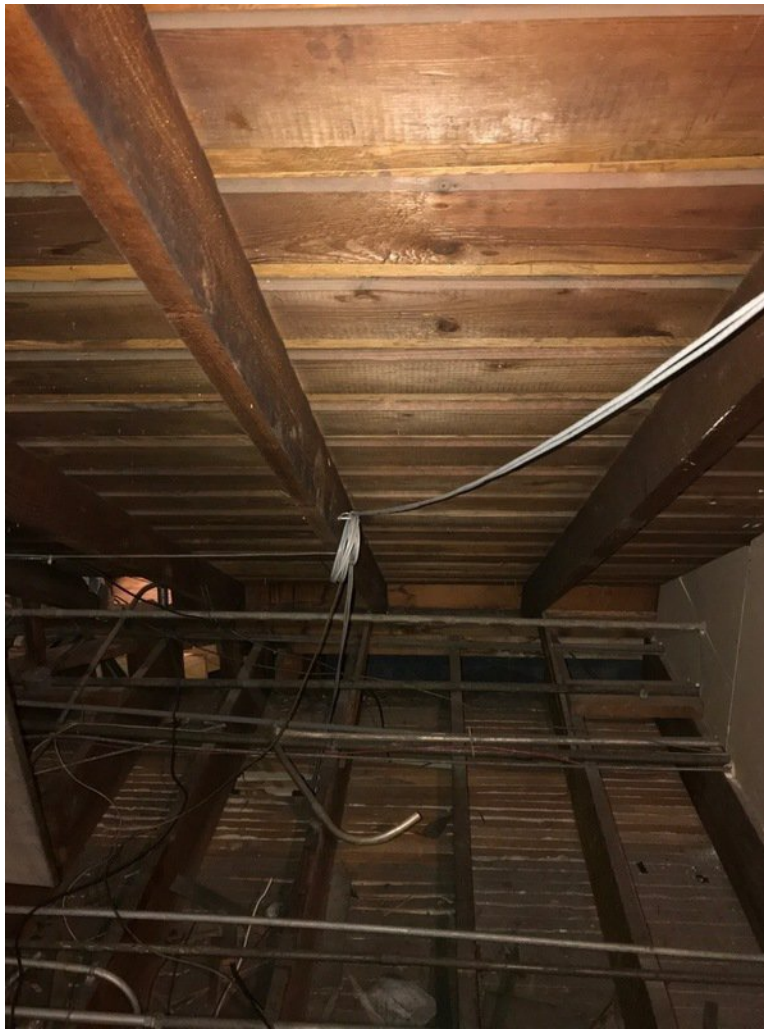
Figure 1-9. Attic area showing typical framing
